PROPERTY CONDITION ASSESSMENT AND 'LEVEL-OF-USE' REPORT

January 25th, 2017

Johnson County Poor Farm - Johnson County, IA

Completed by: HBK Engineering - 509 South Gilbert Street, Iowa City, IA, 52240

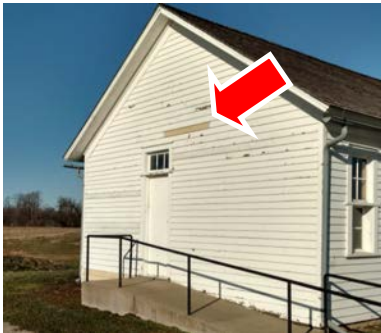
Photo - 1

Siding showing signs of distress in multiple areas, needs to be repaired or replaced.

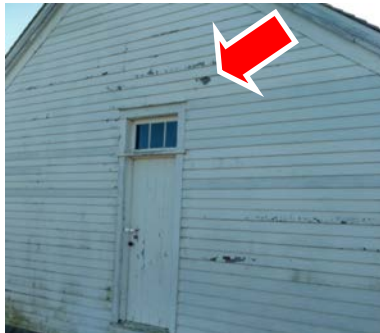
Photo - 2

Siding showing signs of distress in multiple areas, needs to be repaired or replaced.

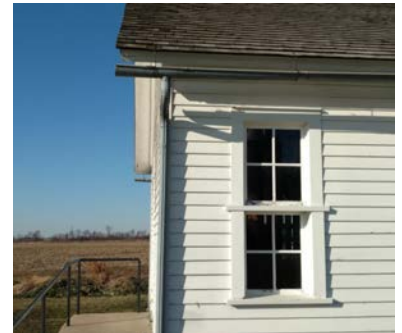
Photo - 3

Windows of the asylum appear to have been replaced recently, in good condition.

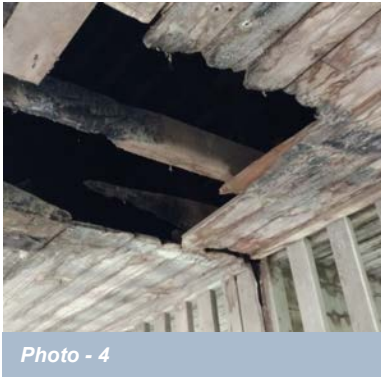
Photo - 4

Hole in ceiling caused by fire.

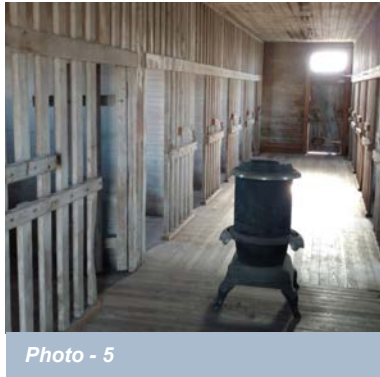
Photo - 5

Overall layout of the asylum, looking in from front door.

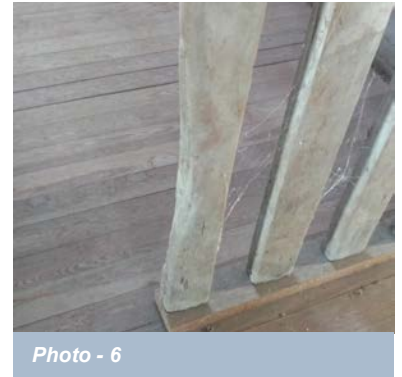
Photo - 6

Floor boards all in good condition throughout asylum.

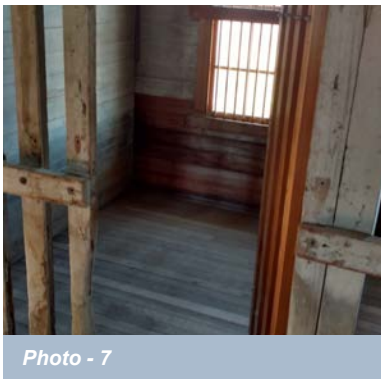
Photo - 7

Floor boards all in good condition throughout asylum.

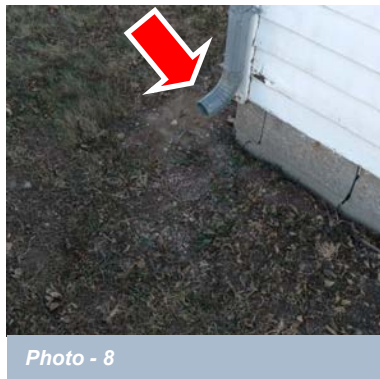
Photo - 8

Inadequate drainage away from the foundation.

- ◆ Improve gutters/downspouts on ASYLUM to promote drainage away from foundation and minimize the risk of washout.
- ◆ Improve gutters/downspouts on DAIRY BARN to promote drainage away from foundation and minimize the risk of washout.

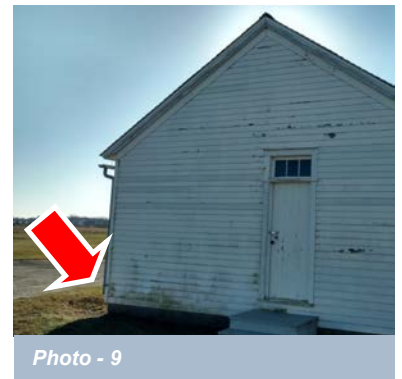
Photo - 9

Inadequate drainage away from the foundation.

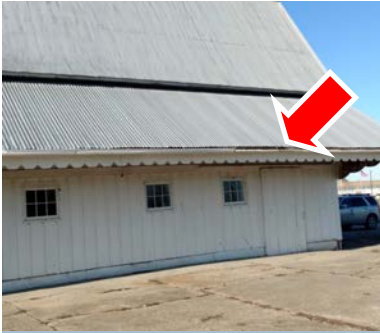
Photo - 1

Gutter not adequate to handle total capacity of water in a rain event, need better drainage away from structure.

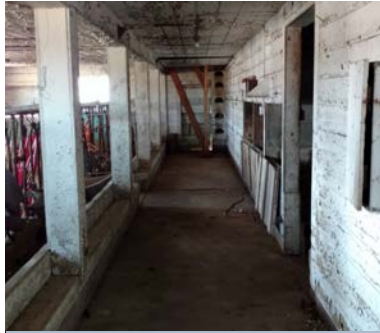
Photo - 2

Walkway on first floor. Walls, columns and ceiling all appear to be in serviceable condition.

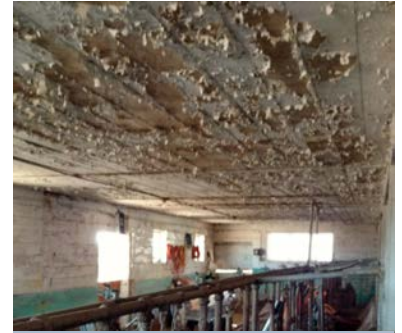
Photo - 3

Paint peeling off ceiling, assumed to be lead paint, will need to be removed.

There appears to be a significant amount of suspect hazardous materials. In particular, there is peeling paint that may contain lead. There is also the possibility of asbestos containing materials. Due to the unique nature of this work, thorough investigation should be performed by qualified individuals.

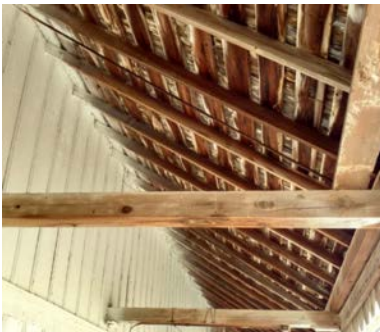
Photo - 4

Shed roof/ Overhang in serviceable condition, some water damage.

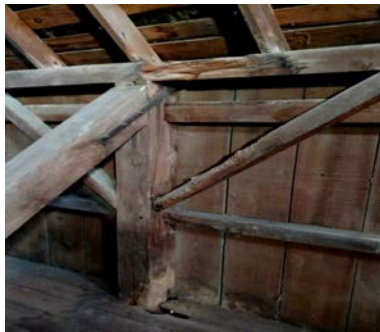
Photo - 5

Water damage to members in the hay loft. Leak that caused damage seems to have been repaired but should be monitored.

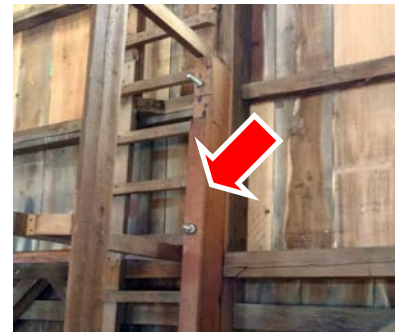
Photo - 6

Structural repair made to member (Member added approx. 6"x4" attached with carriage bolts) on the south wall near stairs.

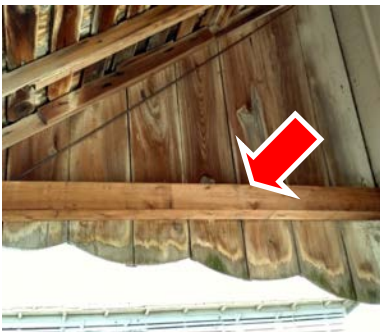
Photo - 7

Structural wood beam (4"x4") on the Southwest corner of shed roof/ overhang has recently been replaced, rafter above has member sistered to it.

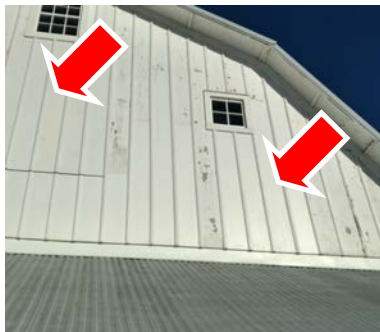
Photo - 8

Siding appears to have been recently replaced in some areas.

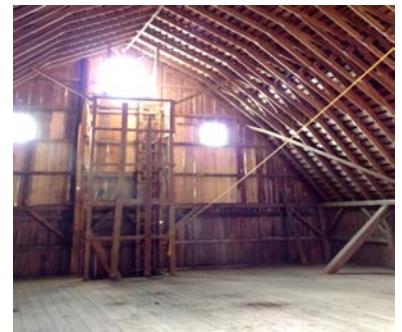
Photo - 9

Hay loft floor in serviceable condition throughout, no spongy spots or damage noted.

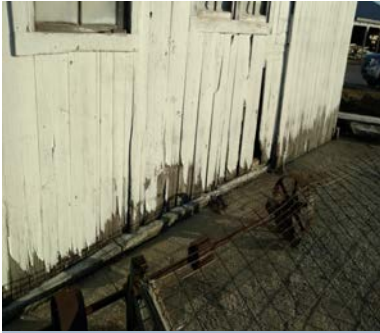
Photo - 1

Siding needing replaced.

- Roof sheathing rotted out in multiple places resulting in roof leaking, needs to be replaced.
 - Siding around structure has failed in multiple places, needs to be replaced.

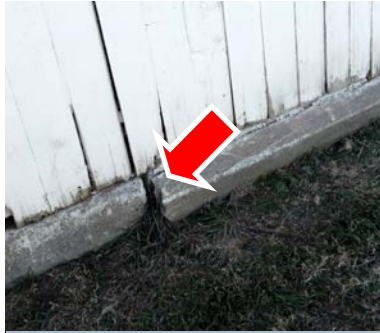
Photo - 2

Footing supporting exterior wall is cracked. Depth of footing unknown.

- ◆ WEST BARN
 - Foundation is inadequate and badly degraded. Significant repairs are required to stabilize. Considering the requested use of this structure, a series of underpinning & jacking will need to be completed to create a safe and usable facility.

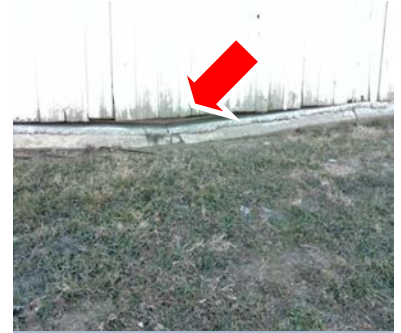
Photo - 3

Footing supporting the west wall has settled enough that footing is no longer in contact with load bearing column.

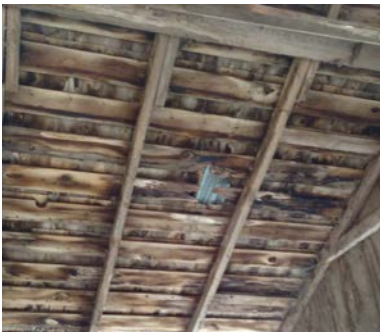
Photo - 4

Roof in need of repair, several spots are showing signs of leaking, some damage might pre date the metal roof, however metal roof likely leaking in spots.

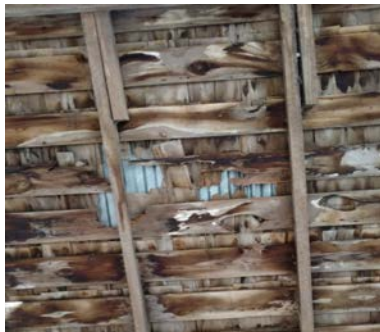
Photo - 5

Roof in need of repair, several spots are showing signs section loss, some damage might pre date the metal roof, however metal roof likely leaking in spots.

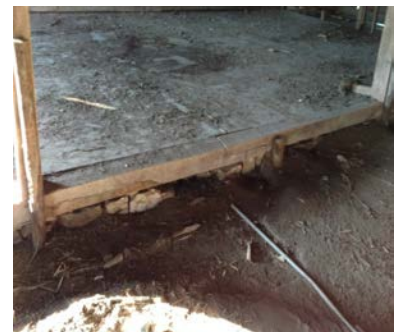
Photo - 6

Main columns in the center of building resting on sill plate that bears on limestone. (Depth unknown)

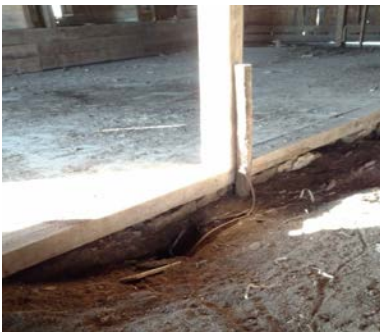
Photo - 7

Main columns in the center of building resting on sill plate that bears on limestone. (Depth unknown)

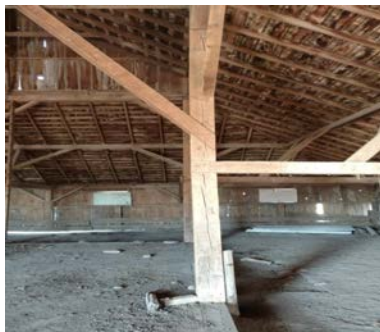
Photo - 8

Typical column out of plumb due to footing/foundation settlement both under the column and of the attached exterior wall.

- Several lateral structural elements missing from facility. Has caused concerning amounts of differential settlement. Structural members should be added to restore lateral stability.

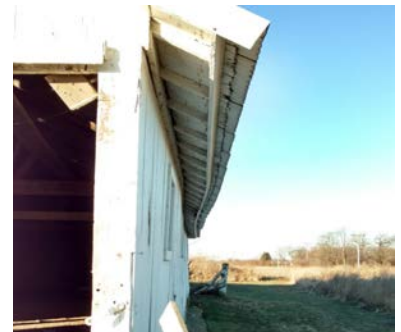
Photo - 9

Showing building out of straightness and the lack of adequate drainage away from the structure.
