PROPERTY CONDITION ASSESSMENT AND 'LEVEL-OF-USE' REPORT

January 25th, 2017

Johnson County Poor Farm - Johnson County, IA

Completed by: HBK Engineering - 509 South Gilbert Street, Iowa City, IA, 52240

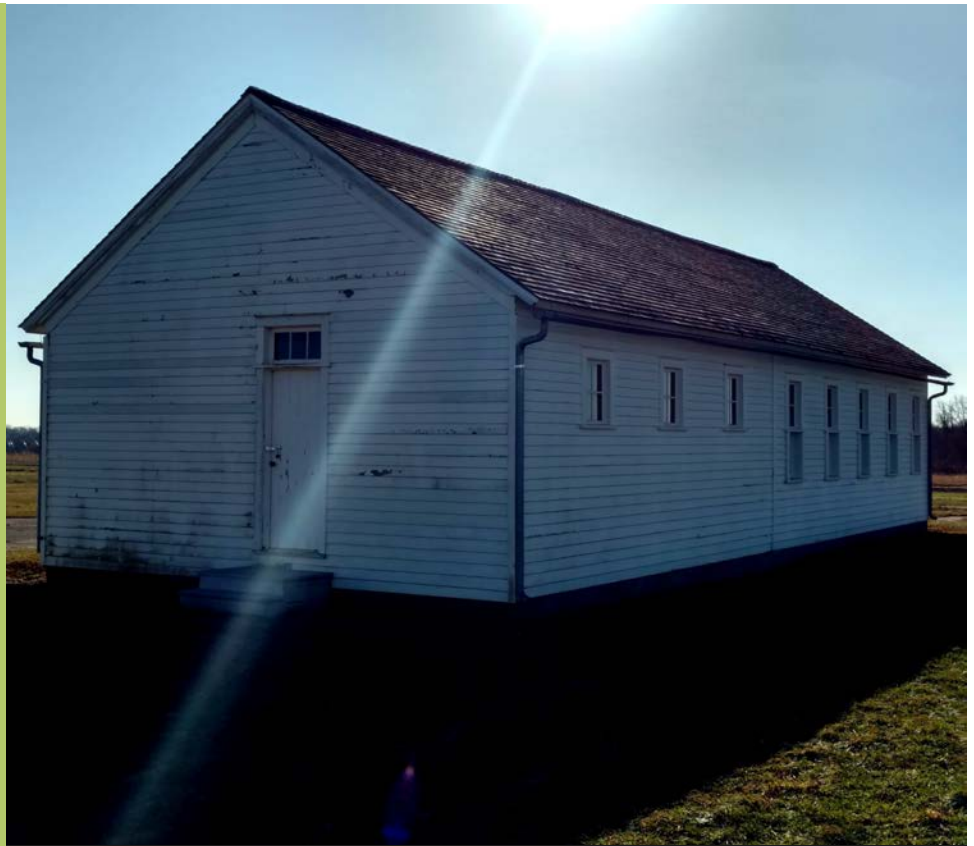
Asylum during the inspection on December, 27th 2016

- Interior flooring structure appears well maintained and in good condition. (Photo 5,6 & 7)
- Water damage marks on ceiling throughout. Not wet at time of inspection, water damaged appears to have occurred before current roof was installed.
- Hole in ceiling from apparent fire (Date unknown), hasn't been repaired likely for historical reasons. (Photo 4)
- Inadequate drainage away from the foundation. (Photo 8 & 9)
- Siding in serviceable condition but in need of repairs in some areas. (Photo 1 & 2)
- Windows appear to be recently replaced and are in good condition. (Photo 3)

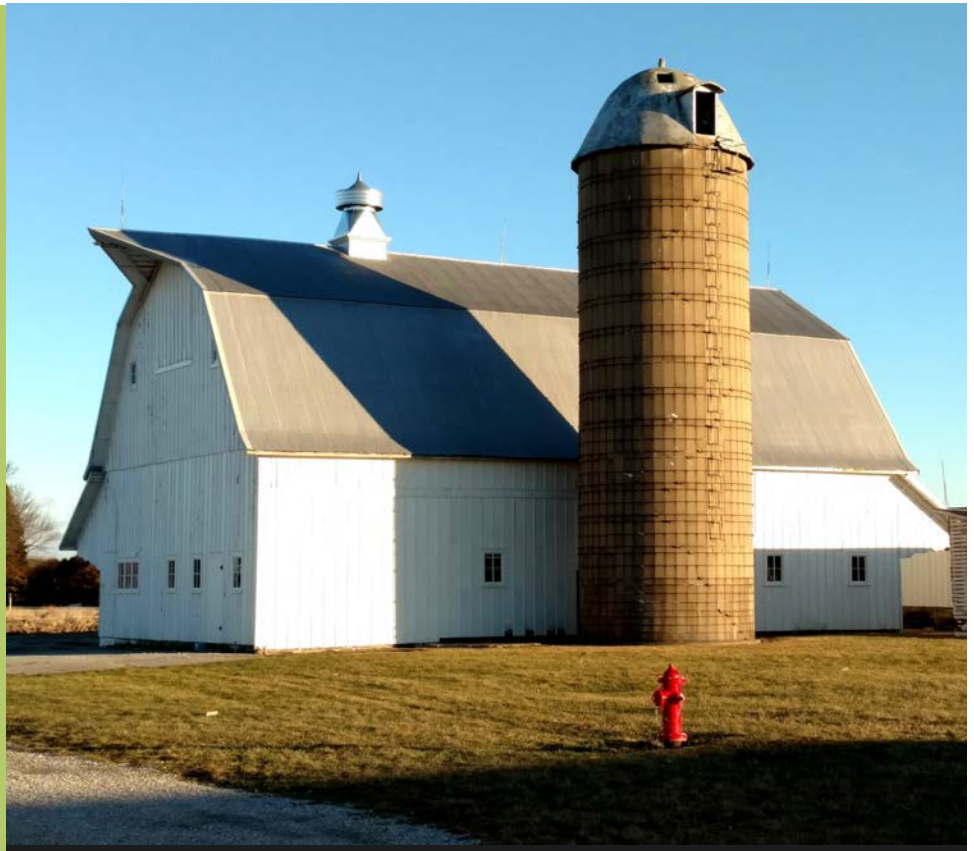
Dairy Barn during the inspection on December 27th, 2016.

- Siding is in serviceable condition and in several spots have recently been repaired or replaced.
- Drainage of water away from building and foundation is not adequate. (Photo 1)
- Shed roof/overhang is in serviceable condition and appears that repairs were recently made to the Southwest corner. Appears that certain members were replaced and others had new members sistered to them. (Photos 4 & 7)
- Barn should be tested for lead paint and asbestos (Photo 3)
- Wood member, near connection along the east side of the hayloft showing signs of water damage, water damage is believed to be from a leak that has been previously fixed. (Photo 5)

- ◆ Improve gutters/downspouts on ASYLUM to promote drainage away from foundation and minimize the risk of washout.
- ◆ Improve gutters/downspouts on DAIRY BARN to promote drainage away from foundation and minimize the risk of washout.

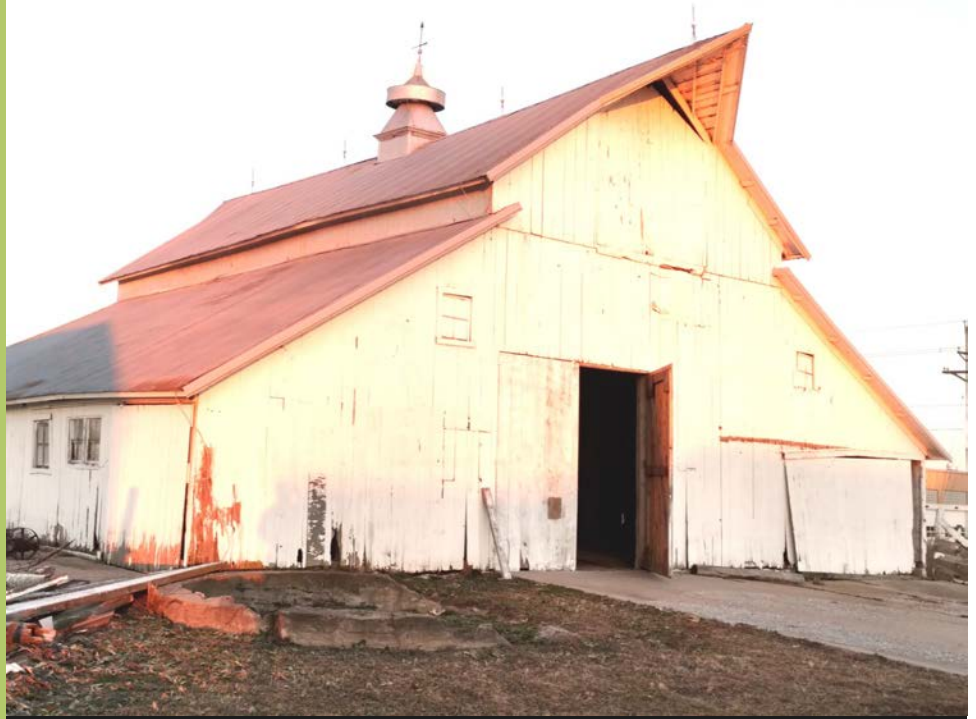
West Barn during the inspection on December 27th, 2016

- Metal roof leaking in multiple spots allowing water infiltration into building. (Photos 4 & 5)
- Drainage of water away from building and foundation is not adequate due to lack of gutters and downspouts. (Photo 9)
- Footings supporting exterior walls have heaved, buckled and failed in multiple locations, has caused lateral shifting and racking of the structure. (Photos 2 & 3)
- Footings under the main center columns are not adequate and should be replaced. (Photos 6 & 7)
- Beam structure or possible hay loft in the center of the building has been removed compromising the structures lateral system and structural integrity.
- Siding has failed in many areas around the building and should be replaced. (Photo 1)
- Barn should be tested for lead paint and asbestos.

- ◆ WEST BARN
 - Foundation is inadequate and badly degraded. Significant repairs are required to stabilize. Considering the requested use of this structure, a series of underpinning & jacking will need to be completed to create a safe and usable facility.

- Several lateral structural elements missing from facility. Has caused concerning amounts of differential settlement. Structural members should be added to restore lateral stability.

- Several structural members are showing signs of section loss or cracking. Should be considered on a case by case basis to determine viable solutions. Sistering members possible some may need replaced.

- Roof sheathing rotted out in multiple places resulting in roof leaking, needs to be replaced.
 - Siding around structure has failed in multiple places, needs to be replaced.
